## PRODUCT TESTING REPORT

**Subject:** COVER TYPE TESTING  
**Prepared For:** DUCAST AUSTRALIA  
**Address:** 2 STACEY STREET BANKSTOWN NSW 2200  
**Attention:** JOHN GILBERT  
**PO Number:** TBC  
**Identification:** DUCTILE IRON COVER AND FRAME 600mm CLEAR OPENING CLASS D/E DA4  
**Specification:** AS 3996: 2019 "Access Covers and Grates"  
**Report Number:** 080376-2 Rev 1  
**Test Personnel:** Chris Vines  
**Date:** 3 September 2019

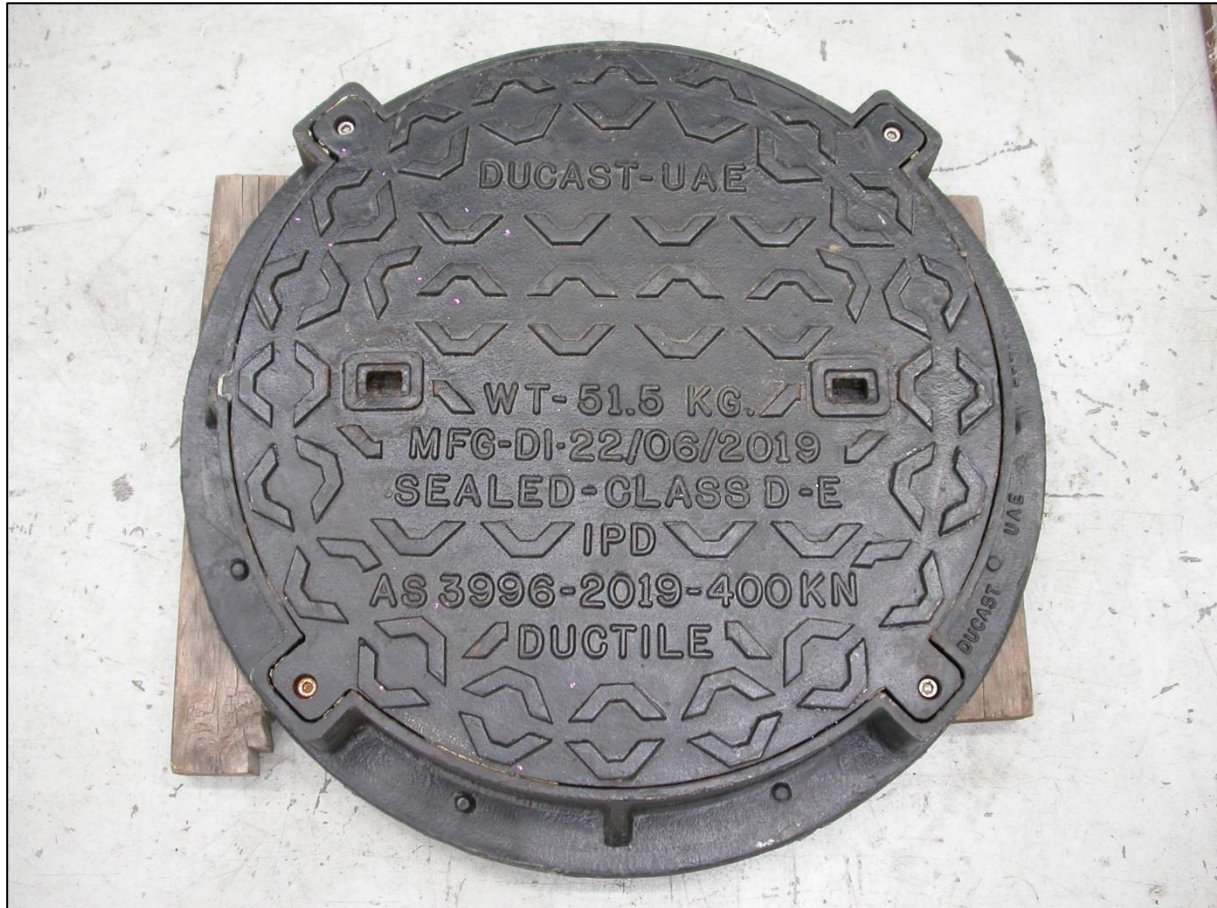
**Figure: 1**

**Subject:** Cover submitted for testing (note the securing bolts for uplift resistance)

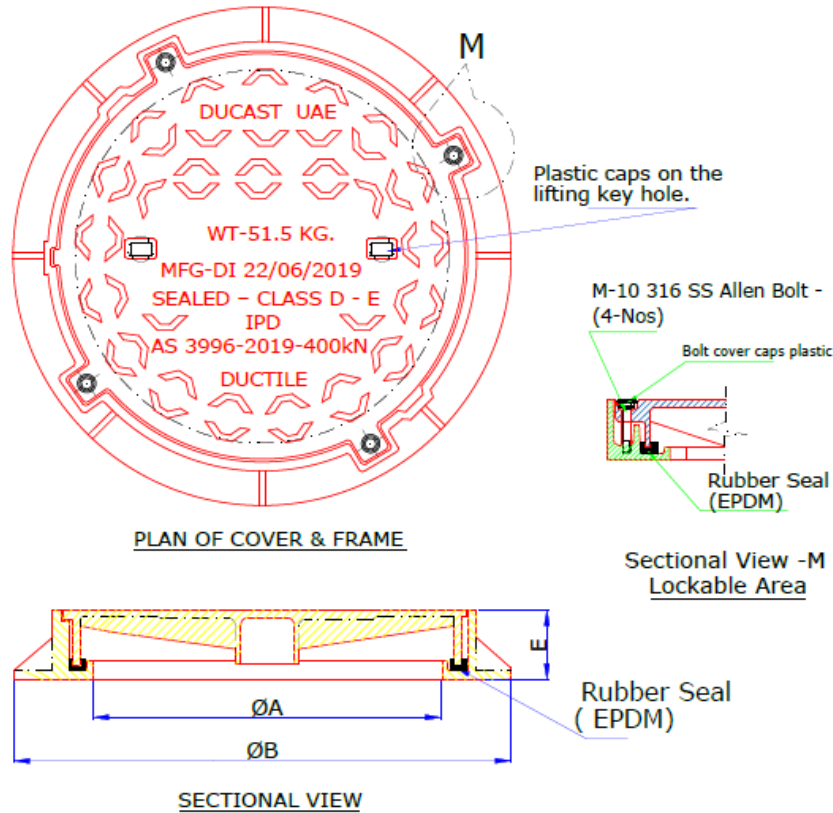
Figure: 2

Subject: Typical cover as supplied

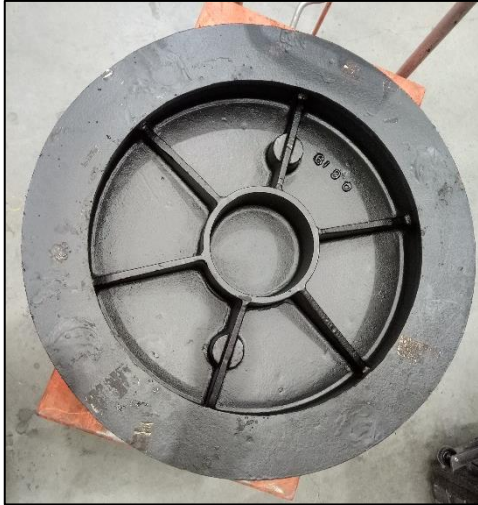
**Figure: 3**  
**Subject:** Cover underside

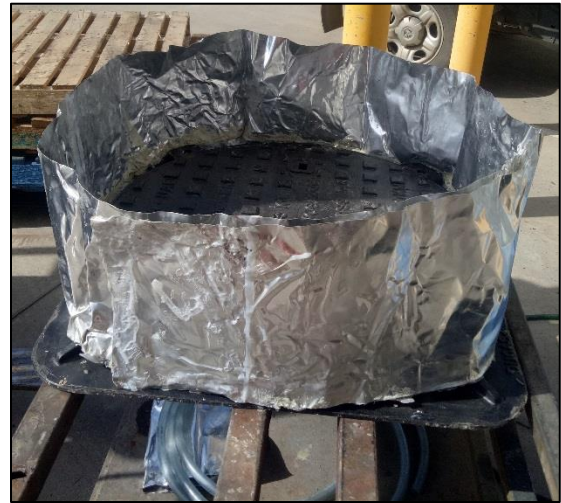
Sealant used:	Unit tested as supplied by client
Coating system:	Unit tested as supplied by client
Water depth:	155mm water (A0986)
Test date:	20/8/2019
Test time:	15 minutes
Observations:	No evidence of leakage in the frame to cover seal

Sealant used:	Unit tested as supplied by client
Coating system:	Unit tested as supplied by client
Test pressure:	0.50 kPa (55mm water in manometer A0986)
Test date:	22/8/2019
Test time:	15 minutes
Observations:	No evidence of leakage in the frame to cover seal (<5mm film of water on lid)

**Figure: 4**  
**Subject:** Test set up for water/gas tightness

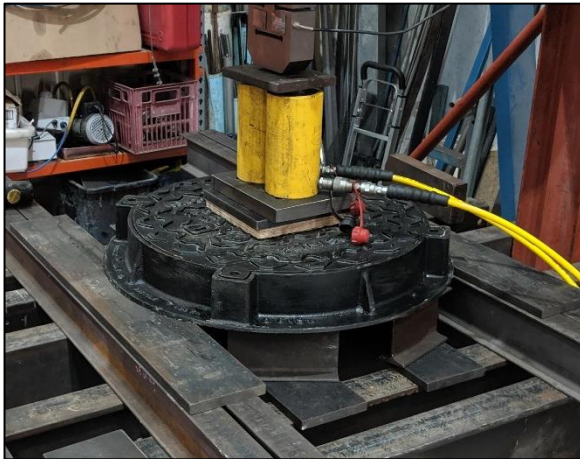
Test Load:	267 kN (Clause 4.2.2.1(a) for CO > 250 mm, Table 3.1 Serviceability design load for Class E = 1) applied via bearing block to the cover in accordance with Appendix C.
Deflection under load:	4.69 mm (No structural failure observed).
Acceptance Criteria:	AS 3996: 2019 Class E $CO/10 = 590/100 = 5.9$ mm (see Table 4.2) Where: CO – circular opening = 590 mm.
Test date:	29/08/2019

Test Load:	5 cycles at 267 kN (see above) applied via bearing block to the cover in accordance with Appendix C
Permanent set:	0.16 mm (No structural failure observed)
Acceptance Criteria:	AS 3996: 2019 Class E $CO/100 = 590/500 = 1.18$ mm Where: CO – circular opening = 590 mm.
Test date:	29/08/2019

Test Load:	400 kN (Clause 4.2.2.1(a) for CO > 250 mm, Table 3.1 Ultimate Limit state design load for Class E) applied via bearing block to the cover for a minimum of 30 seconds in accordance with Appendix C
Observations:	No structural failures observed in the test unit
Acceptance Criteria:	No visible cracking, collapse or other similar forms of structural failure occurred.
Test date:	29/08/2019

**Figure: 5**  
**Subject:** Cover load test

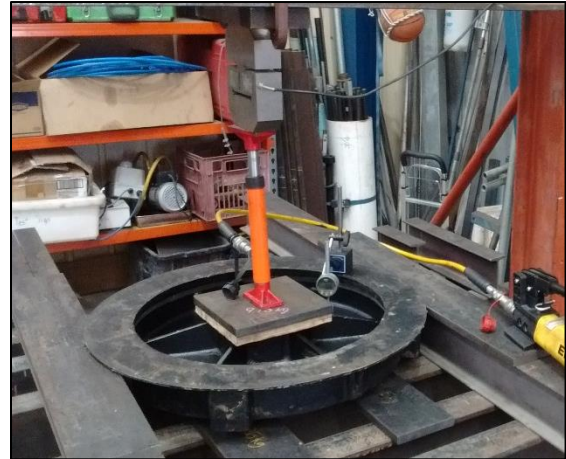
Sealant used:	Unit tested as supplied by client
Test block:	Test block 240 mm x 240 mm square (25 mm plywood)
Test load:	12.5 kN (flood)
Test date:	29/08/2019
Test deflection:	0.11 mm (flood)
Maximum permitted:	12.5mm
Observations:	Deflection was less than the maximum permitted.

**Figure: 6**  
**Subject:** Cover uplift test
