PRODUCT TESTING REPORT

Subject COVER TYPE TESTING
Prepared For: DUCAST AUSTRALIA
Address: 2 STACEY STREET BANKSTOWN NSW 2200
Attention: JOHN GILBERT
PO Number: TBC
Identification: DUCTILE IRON COVER AND FRAME 600mm CLEAR OPENING CLASS A/B DA5
Specification: AS 3996: 2019 "Access Covers and Grates"
Report Number: 080376-3
Test Personnel: Chris Vines
Date: 2 September 2019

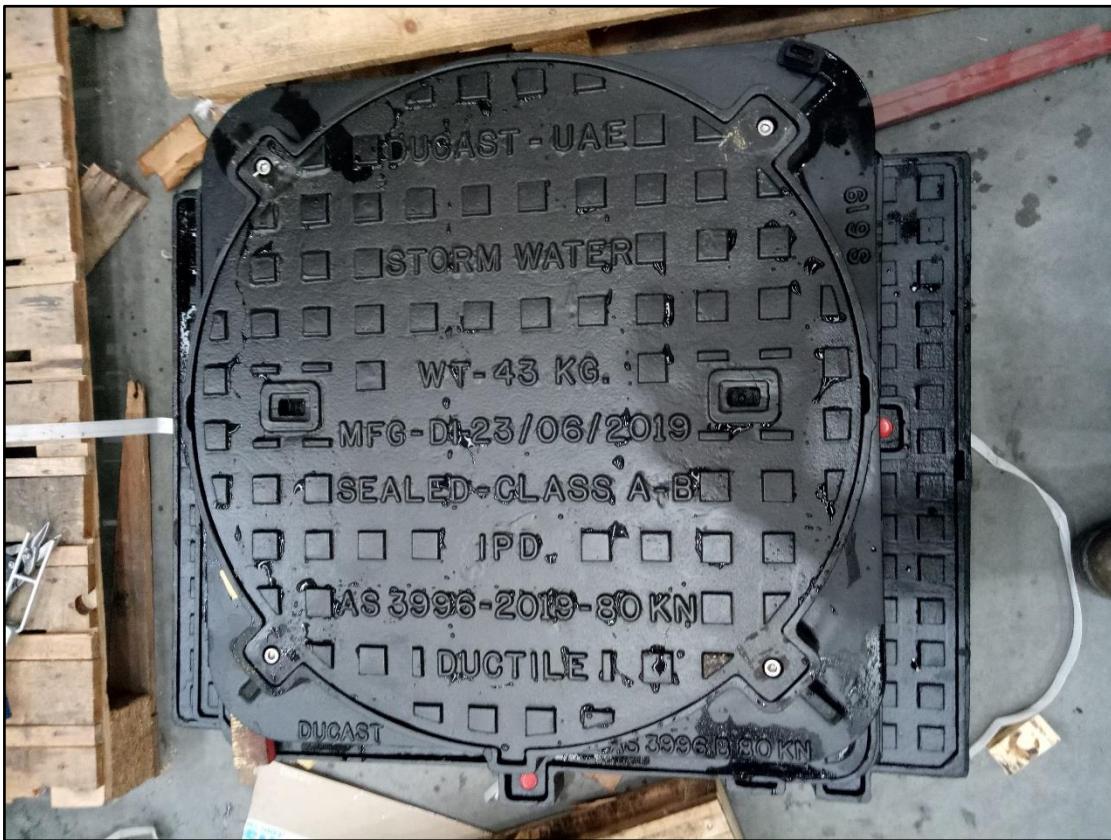
Figure: 1

It was requested that type load testing, water tightness testing, gas tightness testing, uplift testing (traffic and flood) and slip resistance testing be performed on a 600 mm clear opening round cover in its frame. The subject was described as a Class A/B sealed ductile iron cover with 600 mm opening dimensions (refer to Figure 1).

Subject: Cover submitted for testing (note the securing bolts for uplift resistance)

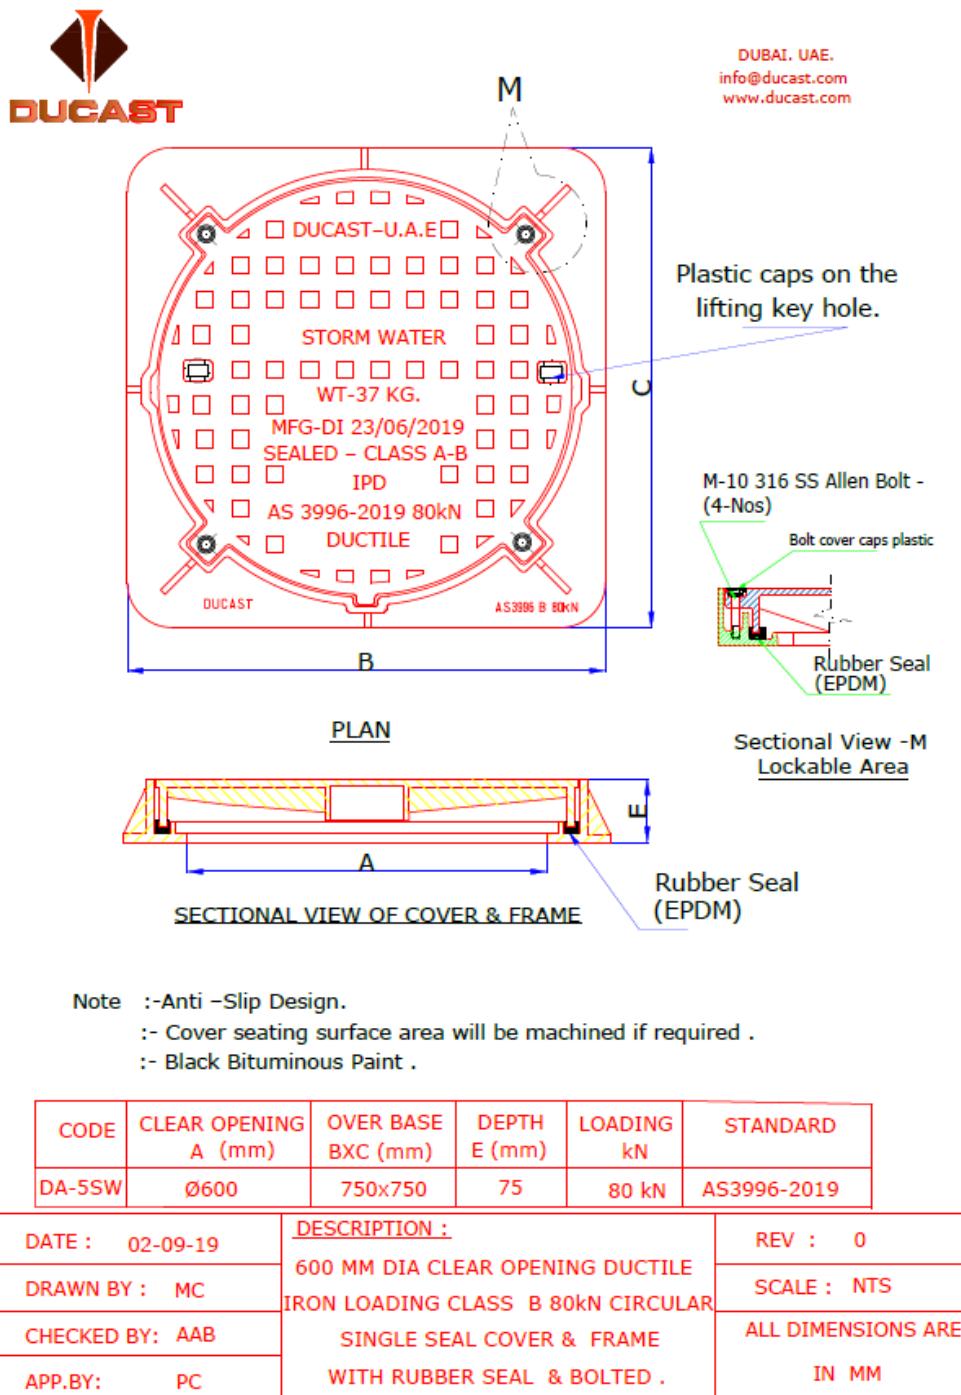
Figure: 2

Subject: Typical cover as received

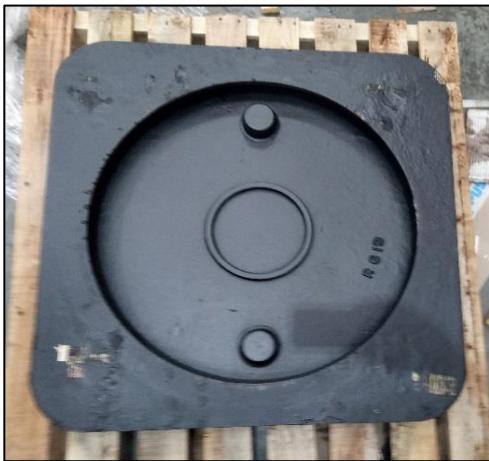
Figure: 3

Subject: Cover underside

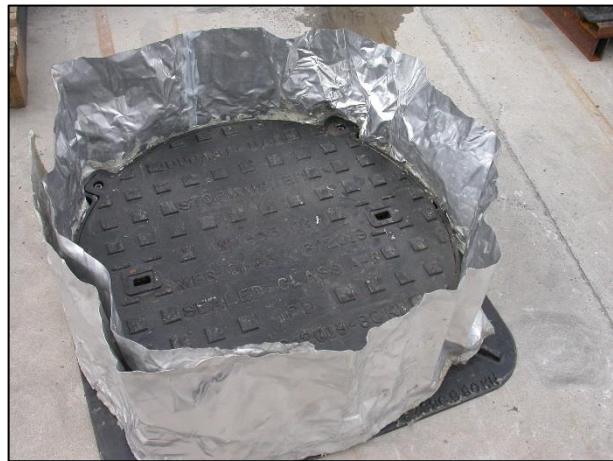
Figure: 4

Sealant used:	Unit tested as supplied by client + Denso sealing grease
Coating system:	Unit tested as supplied by client
Water depth:	153mm water (A0986)
Test date:	19/8/2019
Test time:	15 minutes
Observations:	No evidence of leakage in the frame to cover seal

Sealant used: Unit tested as supplied by client+ Denso sealing grease
Coating system: Unit tested as supplied by client
Test pressure: 0.50 kPa (56mm water in manometer A0986)
Test date: 20/8/2019
Test time: 15 minutes
Observations: No evidence of leakage in the frame to cover seal (<5mm film of water on lid)

Subject: Test set up for water/gas tightness

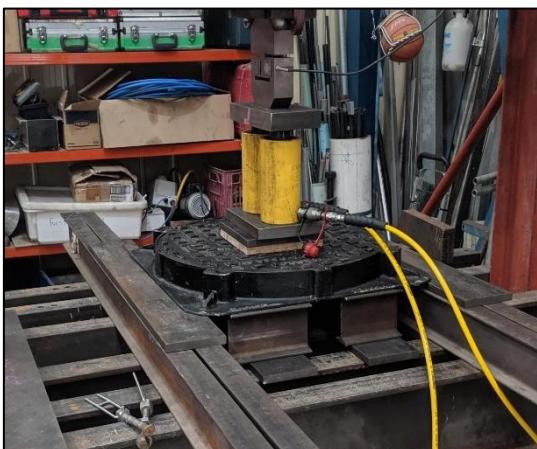
Figure: 5

Test Load:	53 kN (Clause 4.2.2.1(a) for CO > 250 mm, Table 3.1 Serviceability design load for Class B = 1) applied via bearing block to the cover in accordance with Appendix C.
Deflection under load:	9.12 mm (No structural failure observed).
Acceptance Criteria:	AS 3996: 2019 Class B $CO/45 = 600/45 = 13.3 \text{ mm}$ (see Table 4.2) Where: CO - circular opening = 600 mm.
Test date:	21/08/2019

Test Load:	5 cycles at 53 kN (see above) applied via bearing block to the cover in accordance with Appendix C
Permanent set:	0.19 mm (No structural failure observed)
Acceptance Criteria:	AS 3996: 2019 Class B $CO/100 = 600/100 = 6 \text{ mm}$ Where: CO - circular opening = 600 mm.
Test date:	21/08/2019

Test Load:	80 kN (Clause 4.2.2.1(a) for CO > 250 mm, Table 3.1 Ultimate Limit state design load for Class B) applied via bearing block to the cover for a minimum of 30 seconds in accordance with Appendix C
Observations:	No structural failures observed in the test unit
Acceptance Criteria:	No visible cracking, collapse or other similar forms of structural failure occurred.
Test date:	21/08/2019

Subject: Cover load test

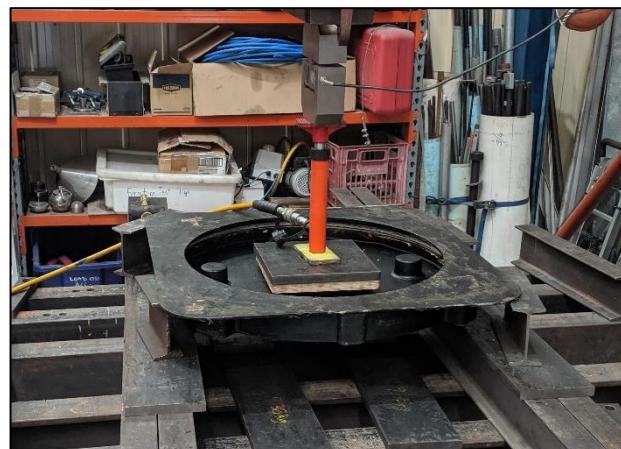
Figure: 6

Sealant used: Unit tested as supplied by client
Test block: Test block 240 mm x 240 mm square (25 mm plywood)
Test load: 13.3 kN (flood)
Test date: 28/08/2019
Test deflection: 0.13 mm (flood)
Maximum permitted: 12.5mm
Observations: Deflection was less than the maximum permitted.

Subject: Cover uplift test
