PRODUCT TESTING REPORT

Subject: COVER TYPE TESTING
Prepared For: DUCAST AUSTRALIA
Address: 2 STACEY STREET BANKSTOWN NSW 2200
Attention: JOHN GILBERT
PO Number: TBC
Identification: DUCTILE IRON COVER AND FRAME 600mm CLEAR OPENING CLASS A/B DA7
Specification: AS 3996: 2019 "Access Covers and Grates"
Report Number: 080376-5
Test Personnel: Chris Vines
Date: 2 September 2019

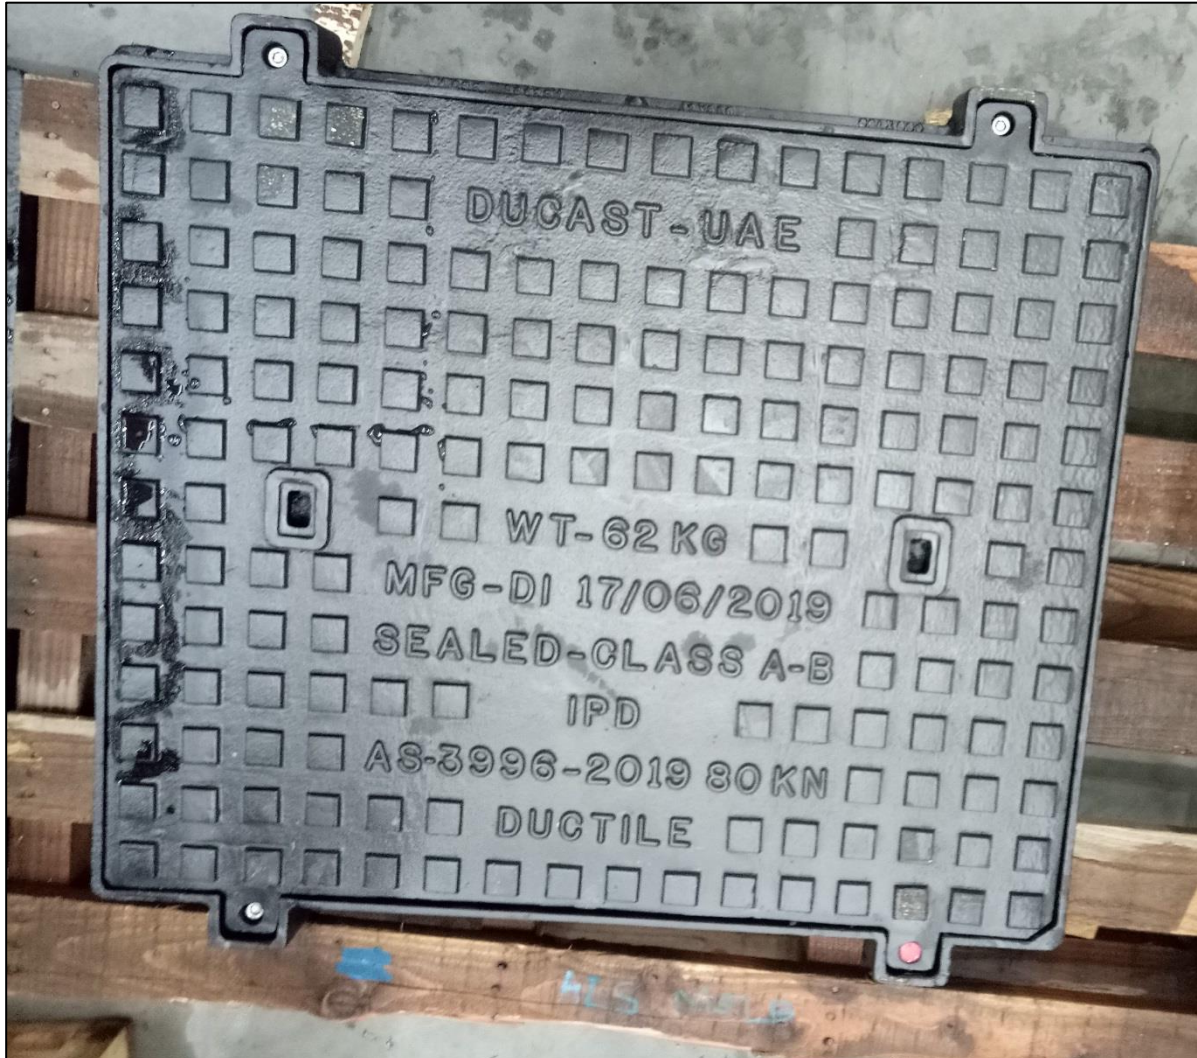
Figure: 1

Subject: Cover submitted for testing (note the securing bolts for uplift resistance under the red caps)

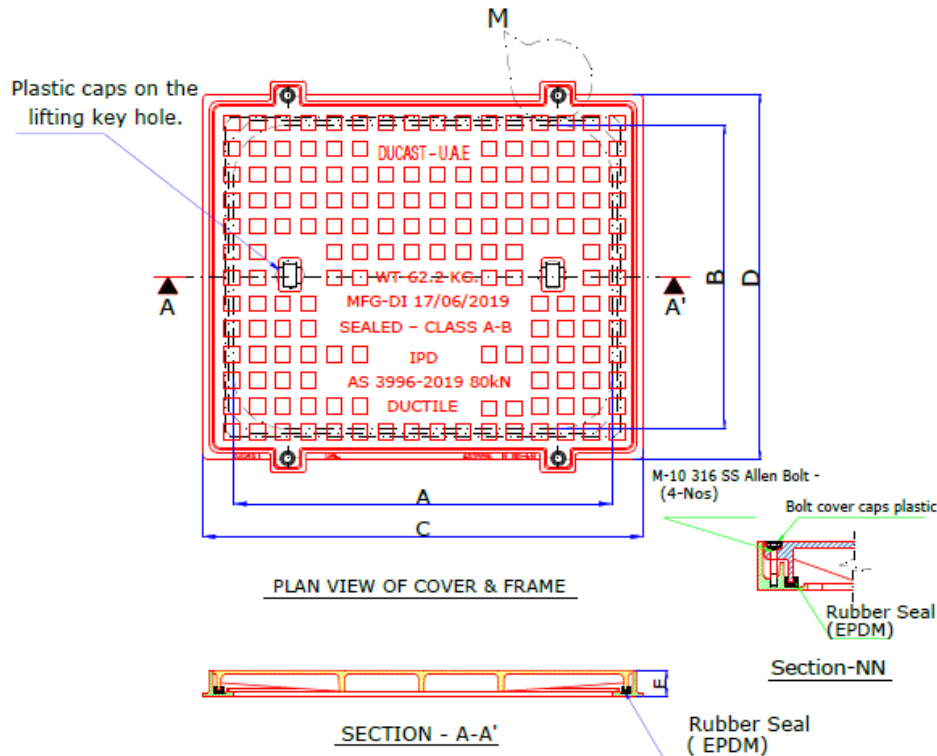
Figure: 2

Subject: Typical design of the cover

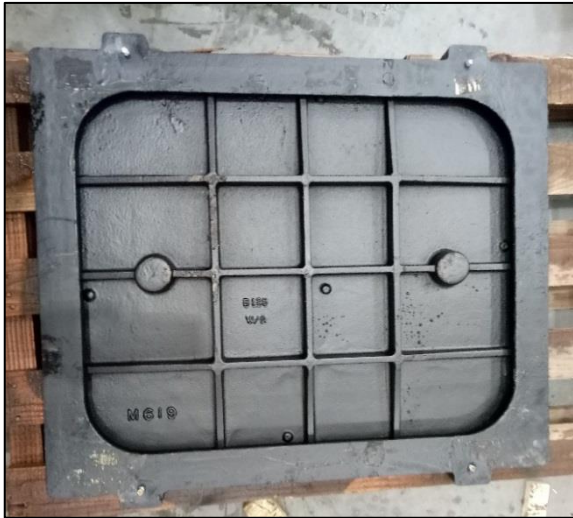
Figure: 3
Subject: Cover underside

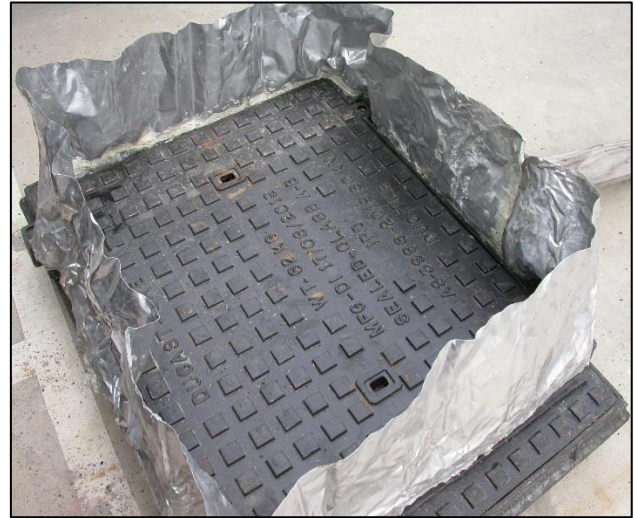
| Observations: | No evidence of leakage in the frame to cover seal |

| Observations: | No evidence of leakage in the frame to cover seal (<5mm film of water on lid) |

Figure: 4
Subject: Test set up for water/gas tightness

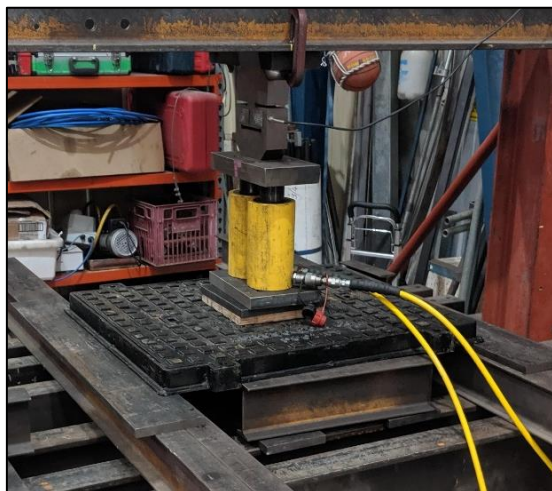
| Deflection under load: | 4.76 mm (No structural failure observed). |

| Permanent set: | 0.11 mm (No structural failure observed) |

| Observations: | No structural failures observed in the test unit |

The cover and frame, DA-7, Class A/B with clear opening of 600 mm **complied** with the type test requirements of AS 3996: 2019 Clauses 4.2.2, 4.2.4, 4.2.5, 4.2.6, and 4.2.8.

Figure: 5
Subject: Cover load test

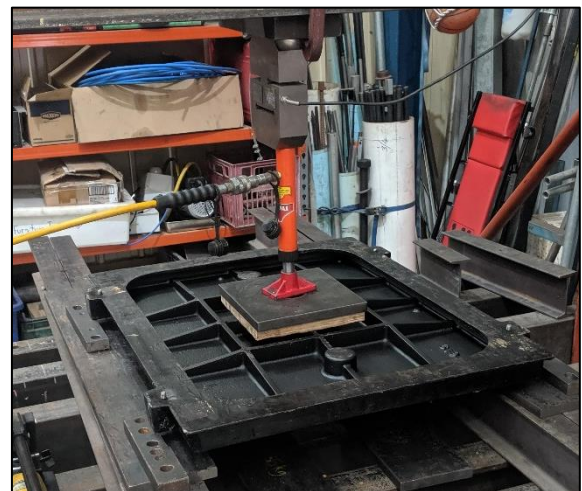
| Test deflection: | 0.21 mm (flood) |
| Observations: | Deflection was less than the maximum permitted. |

Figure: 6
Subject: Cover uplift test
