## PRODUCT TESTING REPORT

**Subject:** COVER TYPE TESTING  
**Prepared For:** DUCAST AUSTRALIA  
**Address:** 2 STACEY STREET BANKSTOWN NSW 2200  
**Attention:** JOHN GILBERT  
**PO Number:** TBC  
**Identification:** DUCTILE IRON COVER AND FRAME 600mm CLEAR OPENING CLASS A/B DA8  
**Specification:** AS 3996: 2019 "Access Covers and Grates"  
**Report Number:** 080376-4  
**Test Personnel:** Chris Vines  
**Date:** 2 September 2019

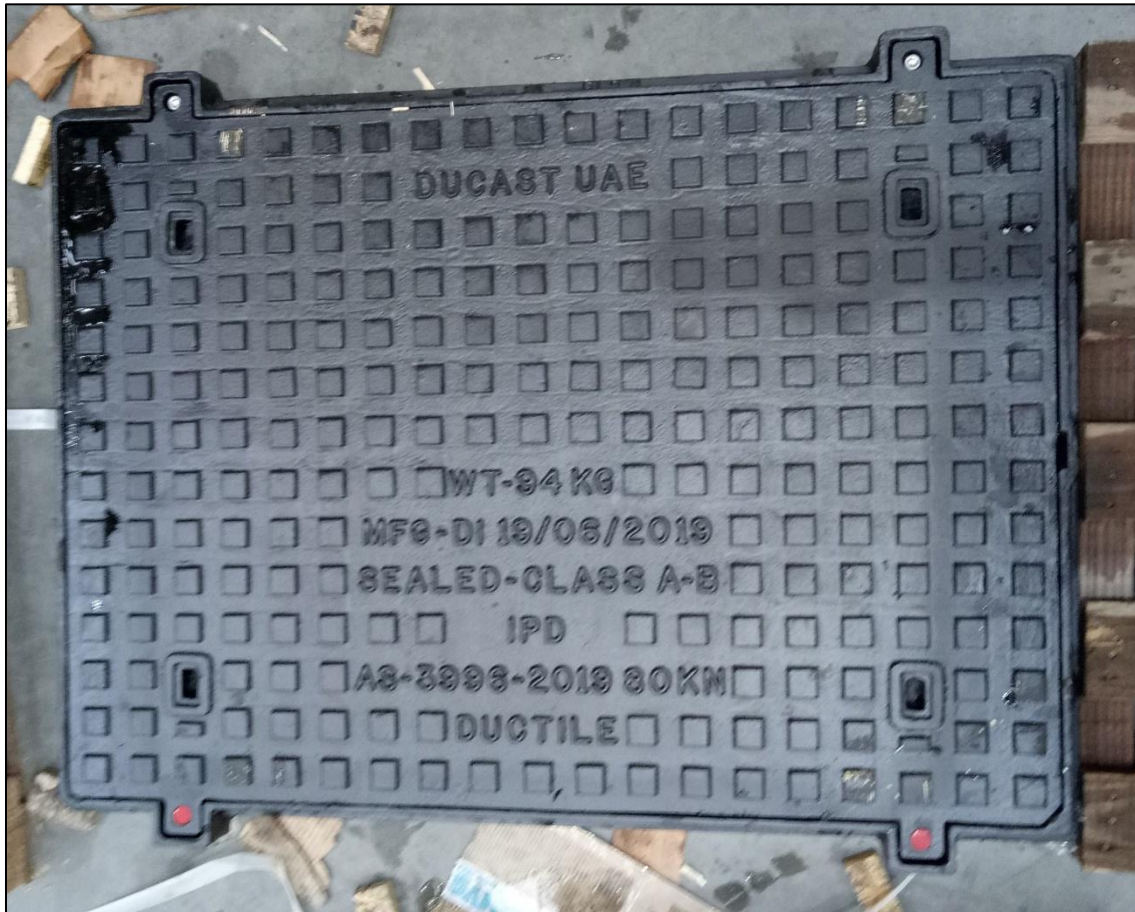
**Figure: 1**

**Subject:** Cover submitted for testing (note the securing bolts for uplift resistance under the red caps)

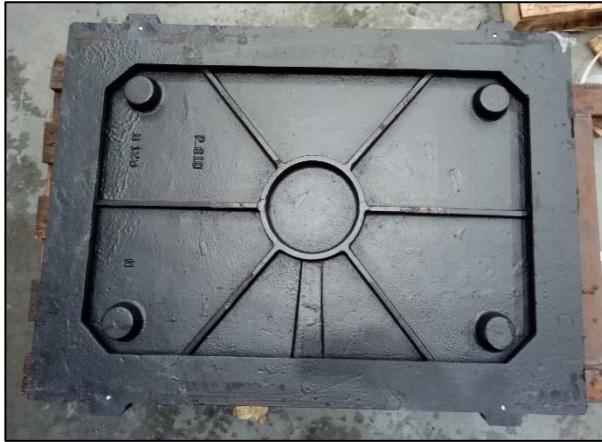
**Figure: 3**  
**Subject:** Cover underside

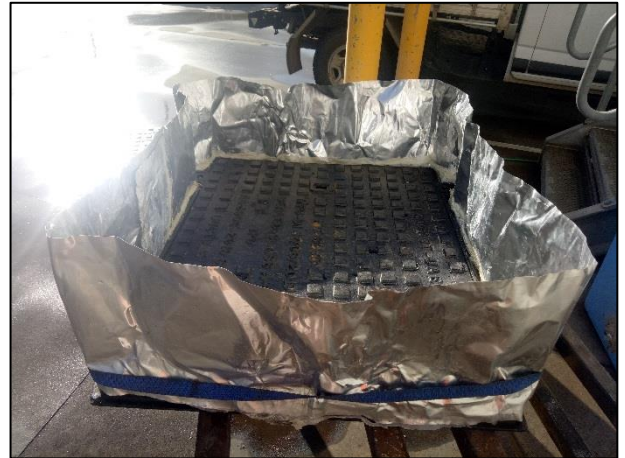
| Observations: | No evidence of leakage in the frame to cover seal |

| Observations: | No evidence of leakage in the frame to cover seal (<5mm film of water on lid) |

**Figure: 4**  
**Subject:** Test set up for water/gas tightness

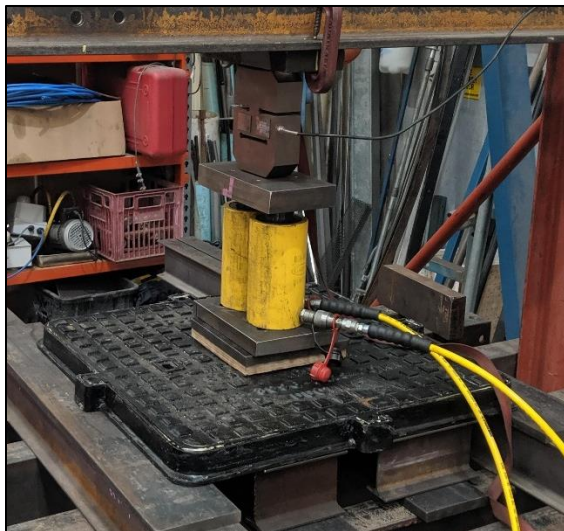
| Deflection under load: | 6.17 mm (No structural failure observed). |

| Permanent set: | 0.15 mm (No structural failure observed) |

| Observations: | No structural failures observed in the test unit |

**Figure: 5**  
**Subject:** Cover load test

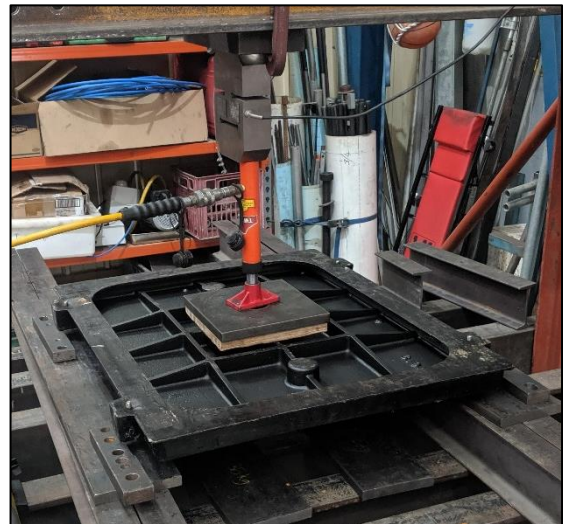
| Test deflection: | 0.14 mm (flood) |
| Observations: | Deflection was less than the maximum permitted. |

**Figure: 6**  
**Subject:** Cover uplift test
