PRODUCT TESTING REPORT

Subject COVER TYPE TESTING
Prepared For: DUCAST AUSTRALIA
Address: 2 STACEY STREET BANKSTOWN NSW 2200
Attention: JOHN GILBERT
PO Number: TBC
Identification: DUCTILE IRON COVER AND FRAME 600mm CLEAR OPENING CLASS D-E DA-3
Specification: AS 3996: 2019 "Access Covers and Grates"
Report Number: 076398-2
Test Personnel: Chris Vines
Date: 23 July 2019

1. INTRODUCTION

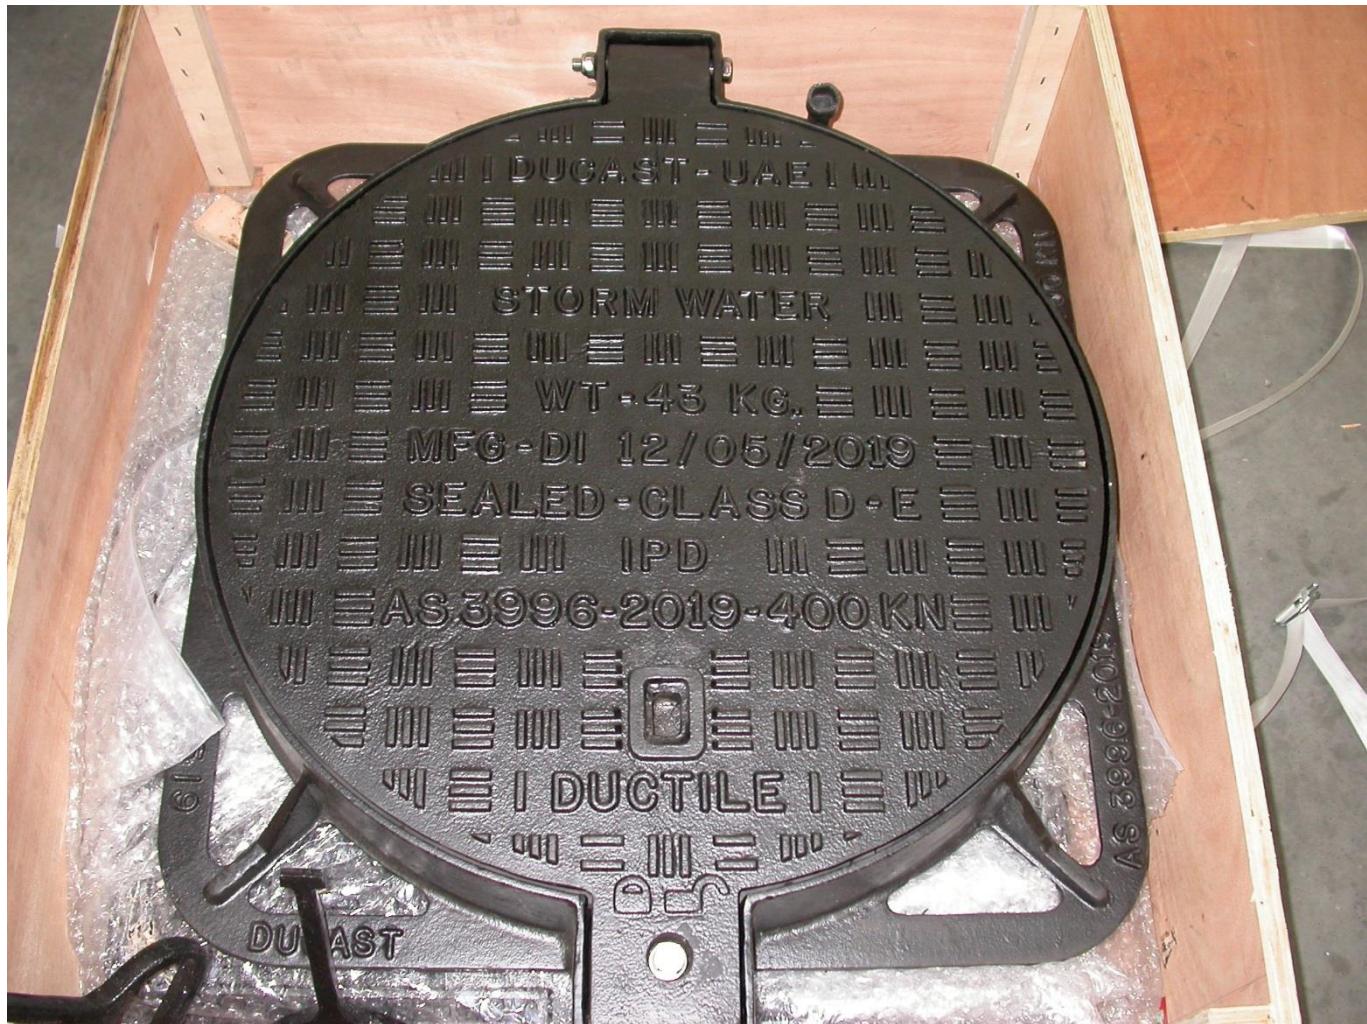
Figure: 1

Subject: Cover submitted for testing (note the hinge at the top end and securing bolts at the bottom)

It was requested that type load testing, water tightness testing, gas tightness testing, uplift testing (traffic and flood) and slip resistance testing be performed on a 600 mm clear opening circular cover in its frame. The subject was described as a Class D/E sealed ductile iron cover with 600 mm opening dimensions (refer to Figure 1) and hinged on one side. Unit was tested with a 70 Duro hardness seal installed.

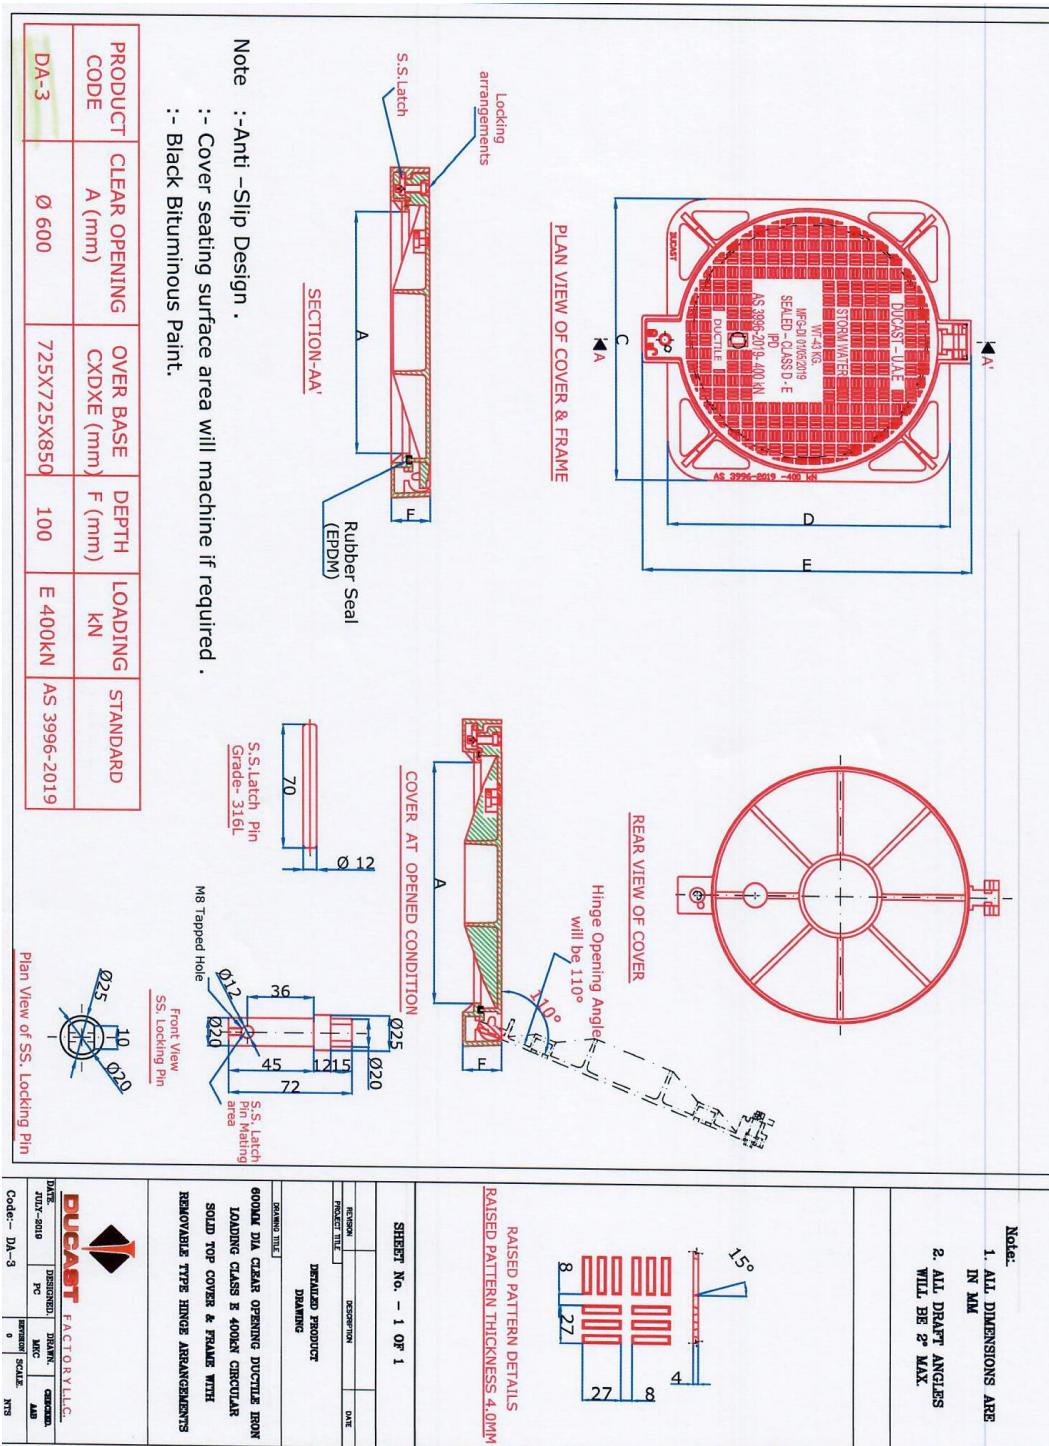
Figure: 2

Subject: Typical design of the cover

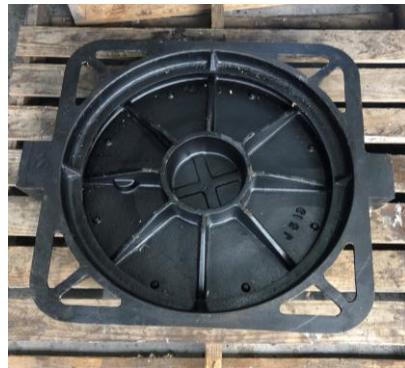
Figure: 3

Subject: Cover underside

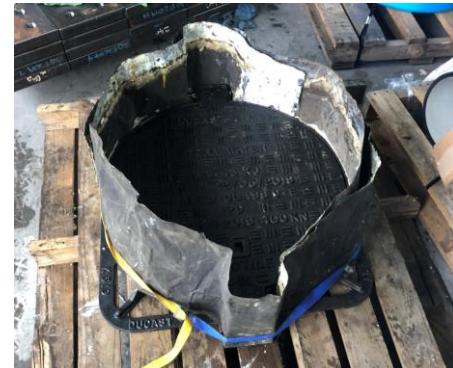
Figure: 4

Subject: Test set up for water/gas tightness

The as submitted cover and its frame were installed in a test fixture which kept water on the topside of the assembly to a known depth and allowed for observation of the underside. The following test parameters were to achieve the result listed below (as per AS 3996-2019 appendix E):

Sealant used: Unit tested as supplied by client
Coating system: Unit tested as supplied by client
Water depth: 152mm water (A0986)
Test date: 11/07/2019
Test time: 10 minutes
Observations: No evidence of leakage in the frame to cover seal

The as submitted cover and its frame were installed in a test fixture which kept air pressure on the underside of the assembly and the top region was covered in a thin film of water. The following test parameters were to achieve the result listed below (as per AS 3996-2019 appendix F):

Sealant used: Unit tested as supplied by client
Coating system: Unit tested as supplied by client
Test pressure: 0.50 kPa (52mm water in manometer A0986)
Test date: 12/07/2019
Test time: 15 minutes
Observations: No evidence of leakage in the frame to cover seal (<5mm film of water on lid)

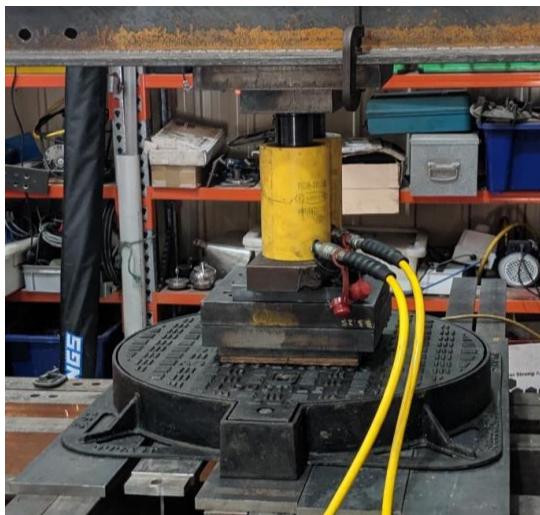
Figure: 5

Subject: Cover load test

The cover was tested in accordance with Appendix C of AS3996. The subject was placed in the loading rig and positioned such that it was supported by the frame in horizontal plane with a minimum 25 mm clearance to the unobstructed opening and the load applied vertically to the geometric centre of the cover. The details of the testing apparatus are as follows:

- Compression test unit (A0260)
- Test block 240 mm x 240 mm square (25 mm plywood)
- Dial Gauge (A0230)

The test load equal to the serviceability design load was gradually applied and elastic deflection was recorded, after which load was released and reapplied for a total of 5 cycles with a minimum of 5s hold at each peak load. After the final load application the permanent set was recorded.

The test load equal to the ultimate limit state design load was then gradually applied and maintained for a minimum of 30 seconds after which the cover was assessed for failures.

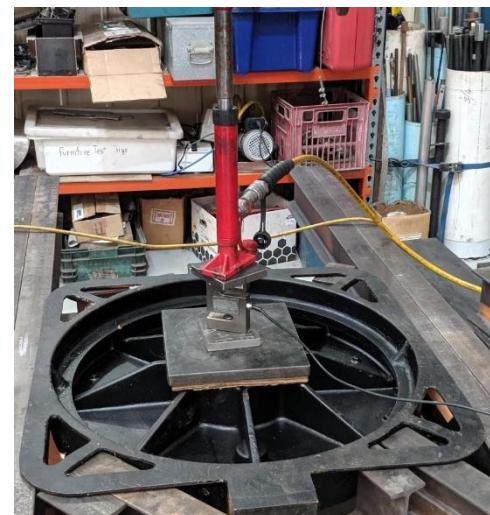
Figure: 6

Subject: Cover uplift test

The as submitted cover and its frame were installed upside down in a test fixture to perform the uplift tests (traffic and flood). The following test parameters were to achieve the result listed below (as per AS 3996-2019 appendix J):

Sealant used:	Unit tested as supplied by client
Test block:	Test block 240 mm x 240 mm square (25 mm plywood)
Test load:	315 N (traffic), 1360 N (flood)
Test date:	07/06/2019
Test deflection:	0.00mm (traffic), 4.18mm (flood)
Maximum permitted:	12.5mm, 12.5mm
Observations:	Deflection was less than the maximum permitted.
